# Plant Services

MOISTURE PLUS  
PH CAN ADD UP  
TO FLOORING  
FAILURE

## CAUSTIC COMMENTS

BY BILL IMHOFF

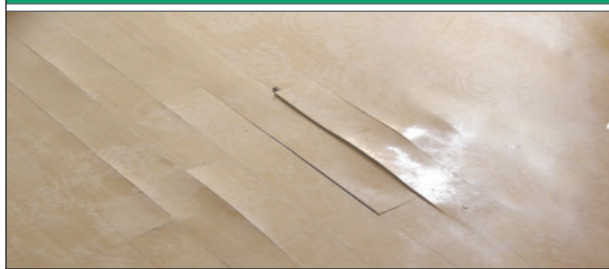
Figure 1. Moisture and pH problems led to strip failure, stressed vinyl composition tile and efflorescence in the seams.

In Austin, Texas, a manufacturing facility struggled for 15 years with tile failures from moisture and high pH. It spent \$250,000 to remove failed floor tile and encapsulate the slab with a moisture barrier to install a warrantable floor covering that provides 2,000-psi strength for the massive machinery that moves across this floor (Figure 1).

Any moisture or pH problem can be fixed at a price. At the Austin high-tech facility, the fix involved removing the flooring and preparing, sealing and cementing the original concrete. This encapsulated the high humidity in the floor. The facility spent hundreds of thousands of

dollars to fix the problem, but it was critical that the flooring be able to bear the weight of large, heavy equipment without buckling.

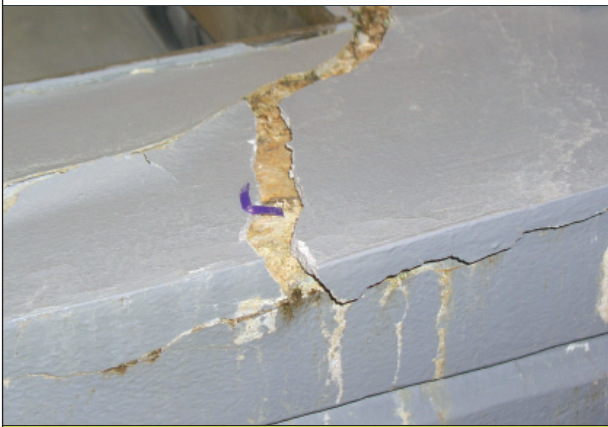
Figure 2. Coating failures and pH irregularity caused cracks in this floor.

Balancing slab pH and moisture level can be challenging and costly. Concrete has a naturally high pH. But, many flooring manufacturers won't warranty installations if the pH is at natural levels, even though moisture is low (Figure 2). Nationwide, moisture and pH-related flooring problems have reached the billion-dollar level annually, according to independent concrete flooring expert Scott M. Tarr, principal engineer at CTL Group, Skokie, Ill. Factors driving these problems include:
